# PROGRESS REPORT

PR 91570-510-5

## DEVELOPMENT OF A HYDROGEN-OXYGEN SPACE POWER SUPPLY SYSTEM

NASA Contract NAS 3-2787

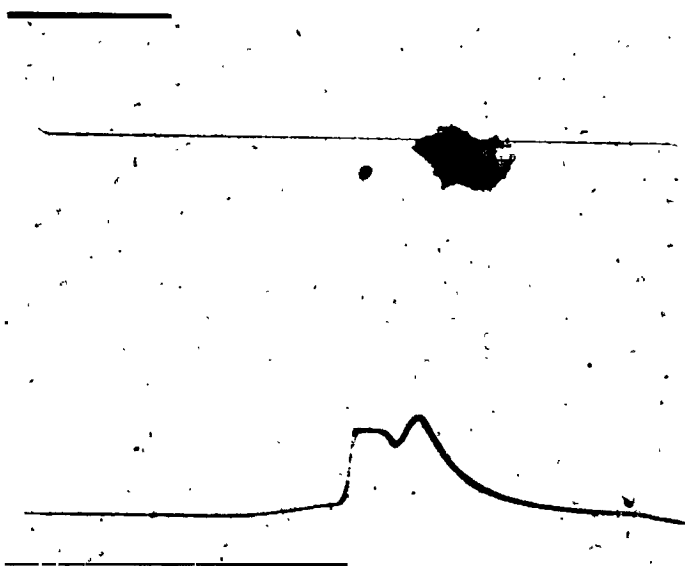
Fig. 27

11-27-63 2:17  
Entry No. 26, Table II  
 $H_2$  Inlet Press = 300  
 $O_2$  Inlet Press = 1000  
Vacuum = 28 in. Hg  
 $H_2$  Inlet Temp = 490  
Speed = 4291 rpm  
Power = 2.61  
BSPC = 2.10 lb/hp-hr  
BMEP = 89 psi  
O/F = 2.10  
% Heat Rejected = 117%

These runs were repeated during a checkout of the recirculating cooling system using Dowtherm "A" as a coolant instead of water. While coolant temperatures and flow ratios were not optimized, a higher cylinder wall temperature was possible, which is believed to be responsible for the slight improvement in performance (From 2.28 lb/hp-hr to 2.10 lb/hp-hr). Pressure-time traces are given in Figs. 26 and 27.
